Route 1 - Costas Garraf

Description

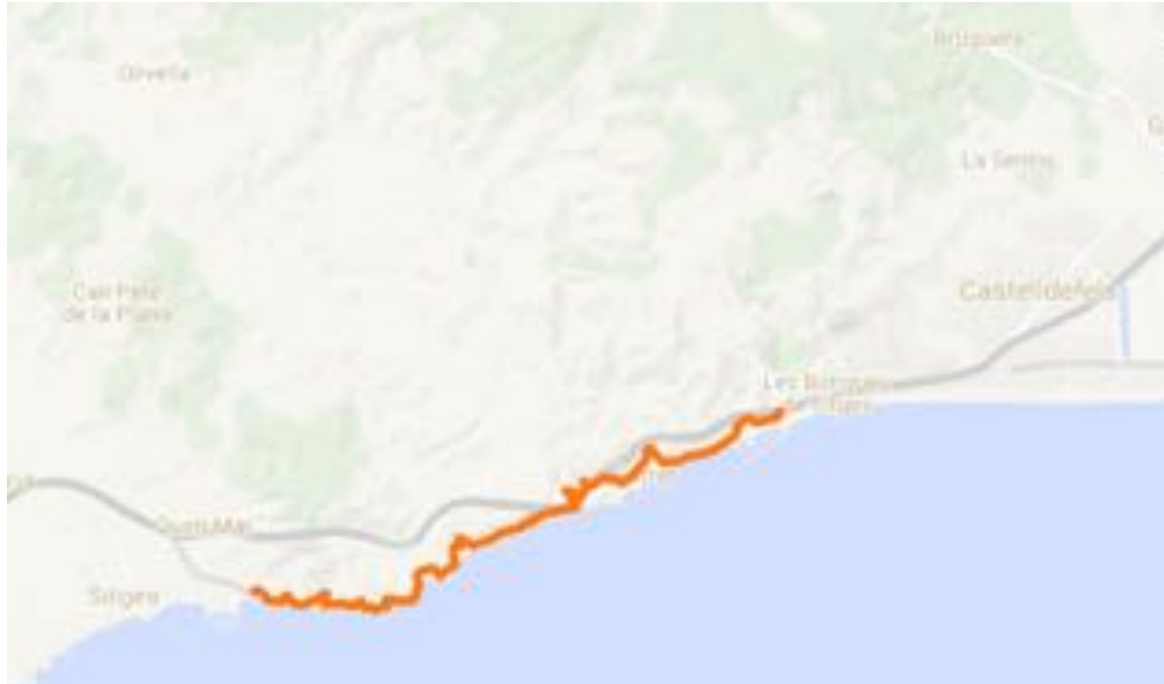
From a perception point of view, this route is challenging due to the combination of many curves, varying gradients, continuous concrete barriers, mountainous terrain and a rather high traffic density. At dusk and dawn, sunlight can blind cameras easily. On the south side, the road has a continuous concrete barrier. On the north side, different road edges can be found such as rock walls (mostly), soil, vegetation, ditches, metallic barriers, concrete barriers and concrete curbs. Road users vary between cars, motorbikes, small trucks and cyclists.

Length	11,9 km
Lane width	3,0 - 4,5 m
Type of road	interurban (2 lanes)
State of road	good
Maximum speed	60 km/h
Number of intersections	8
Number of overhead bridges	0
Number of tunnels	0
Total ascent / descent	319 m / 325 m
Max slope / min slope	22,3% / -25.2 %
Mobile network coverage	poor
